# Early Wear Development in a Novel Mechanical Heart Valve Prosthesis made from Polymeric Materials

The Journal of Heart Valve Disease 2006;15:710-715

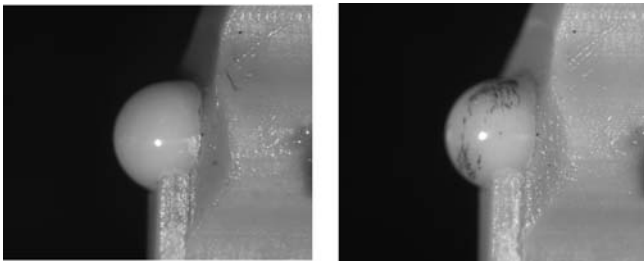
Figure 8: Light microscopy images of a  $ZrO_2$  inlay run in a Ti-6Al-4V housing. Left: before testing. Right: after 10 million load cycles.

A ceramic/metal material couple is considered to be an incorrect combination for use in a mechanical heart valve prosthesis.  $Al_2O_3$  respectively  $ZrO_2$  inlays were integrated into the leaflets and run in a housing made from Ti-6Al-4V. A LM image of a ceramic inlay before testing and after the first inspection interval (10 million load cycles) is shown in Figure 8. As a consequence of the porosity of the ceramics and adhesive wear, a metallic layer was visible on the ceramic inlays. This wear behavior was observed for both tested ceramic/metal material couples.

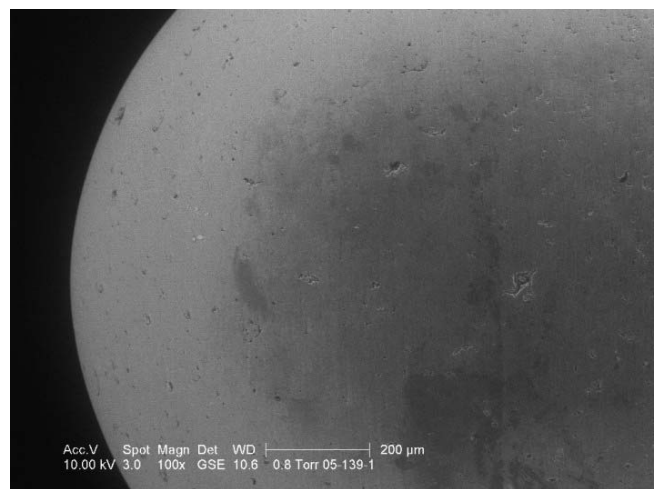
The material couple  $Al_2O_3$ /PEEK should also have the potential to increase the durability of a heart valve prosthesis. However, the SEM image shown in Figure 11 of an alumina inlay before durability testing revealed several surface defects which could be attributed to the manufacturing process. The rough surface of the hard alumina inlays led to increased wear in the

Figure 11: Scanning electron microscopy image of a  $Al_2O_3$  inlay before the durability tests.

pivot cavities in the housing, which was constructed from a soft polymer.
